SEVERE CORROSION AND HYDROGEN EMBRITTLMENT OF RETRIEVED MODULAR BODY TITANIUM ALLOY HIP-IMPLANTS

Danieli B. C. Rodrigues¹, Robert M. Urban², Joshua J. Jacobs², Jeremy L. Gilbert¹

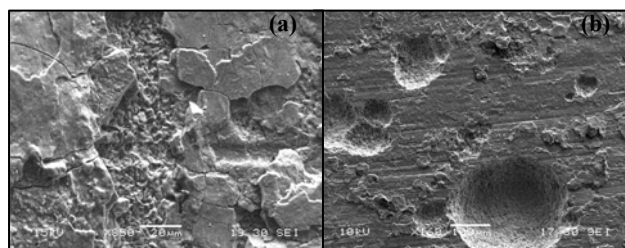
Results/Discussion: Several features beyond the typical evidence of fretting corrosion have been demonstrated in the SEM analysis. In particular, severe pitting of the surface with pits up to $250 \mu\text{m}$ and surface cracking in multiple directions were observed (Figure 1). Assigned peaks for the gamma titanium hydride ($\gamma\text{-TiH}$ at $2\theta = 39.5^\circ$, b peak in Figure 2) were observed for the A component and these results were supported by chemical analysis, which indicated hydrogen concentrations in the range of 0.14 to 0.21 wt. %. These results showed hydrogen concentration more than ten times the concentrations recommended by the ASTM standards for titanium alloys. The B component presented qualitative evidence of hydrogen-induced cracking with

Figure 1. (a) A component showing cracking and delamination (b) Pitting on the B component.

Conclusions: Ti-6Al-4V/Ti-6Al-4V retrieved modular body tapers were shown to have severely corroded taper interfaces which led to pitting, etching, multidirectional surface cracking and delamination based on SEM analysis. The cracking and delamination morphologies in combination with chemical analysis and XRD analysis demonstrated hydrogen embrittlement in the surface layer of one of the two modular components analyzed. The hydrogen generation and absorption are thought to be a consequence of reduction of hydrogen ions present in the taper crevice from the fretting corrosion process.
