Factors Affecting the Performance of Metal Components in Artificial Hips

Vesnovsky, O.¹, Anderson, N.P.¹, Di Prima, M.A.¹, Engh C.A.², Grossman L.W.¹, Hopper, R.H.², Stephen, E.A.¹, Topoleski, L.D.T.^{1,3}

¹US Food and Drug Administration, ²Anderson Orthopaedic Institute, ³University of Maryland, Baltimore County

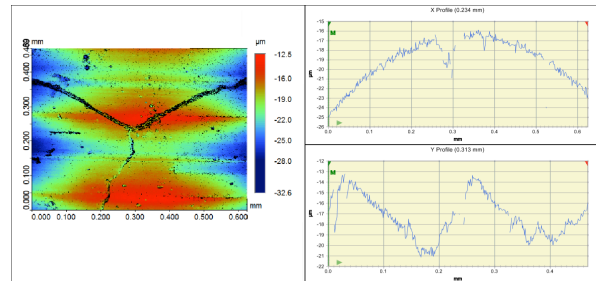
Examination of the retrieved CoCrMo trunnion showed non-uniform wear around its circumference. More wear was evident on the inferior side, where the machining marks were visibly affected. What initially appeared to be fractures on the surface (Fig. 2) are believed to be grain boundaries, etched by corrosive processes at the interface. The depth of the etching was about 6 μm .

BELOW – Figure 2: Surface roughness image showing machining marks and grain boundaries.
